Static Stability Tilt Test

Millbrook Proving Ground Ltd.	
Project	VG0356-001-01
Datapak	MBK16/0491
Test Date	24/05/2016
Issue Date	26/05/2016

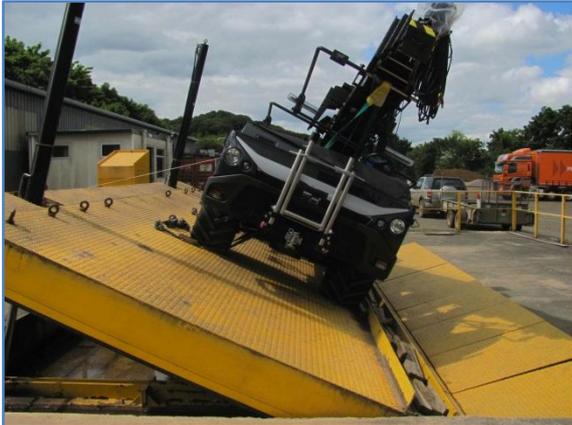
RH Tilt Test	Rear Wheel Lift (°)
Platform	23.4
Body Front	24.4
Body Rear	29.5

Figure 3 - Config. 1, Front View, 23.4° Platform

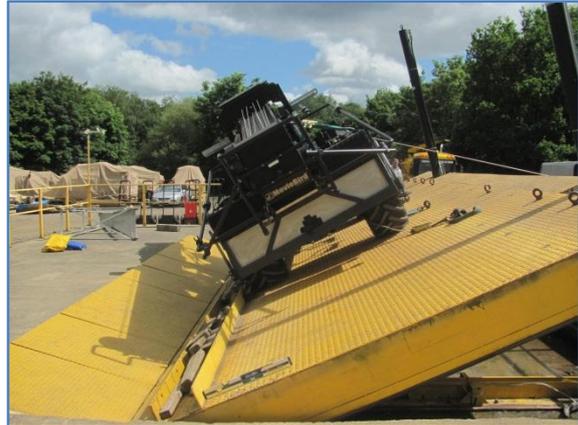
Figure 4 - Config. 1, Rear View, 23.4° Platform

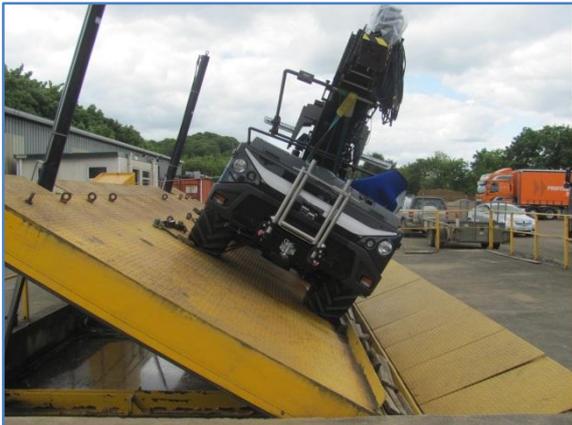
RH Tilt Test	Rear Wheel Lift (°)
Platform	29.7
Body Front	31.0
Body Rear	21.9

Figure 5 - Config. 2, Front View, 29.7° Platform

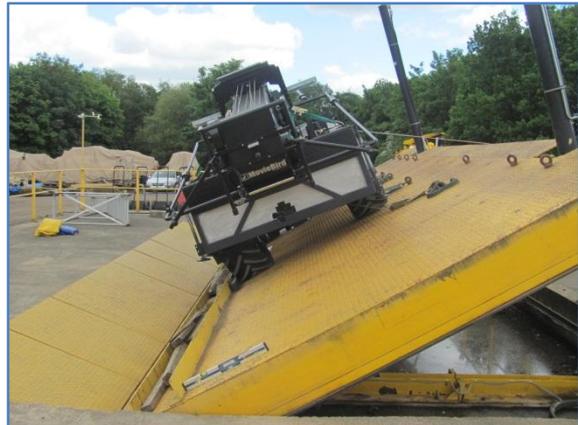
Figure 6 - Config. 2, Rear View, 29.7° Platform

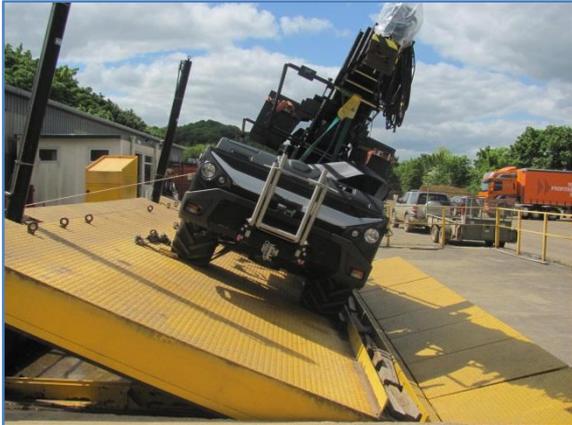
RH Tilt Test	Rear Wheel Lift (°)
Platform	20.5
Body Front	21.1
Body Rear	24.2

Figure 7 - Config. 3, Front View, 20.5° Platform

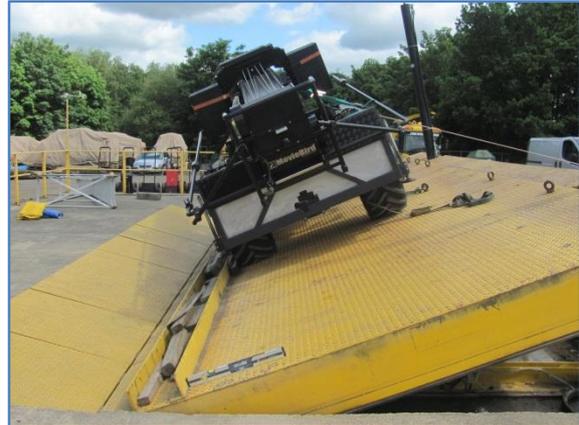
Figure 8 - Config. 3, Rear View, 20.5° Platform

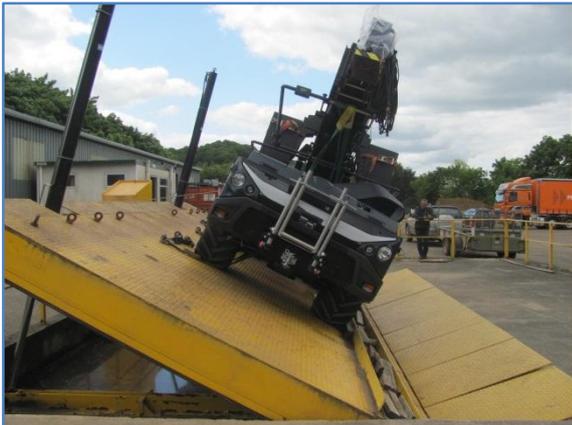
RH Tilt Test	Rear Wheel Lift (°)
Platform	26.7
Body Front	27.8
Body Rear	19.2

Figure 9 - Config. 4, Front View, 26.7° Platform

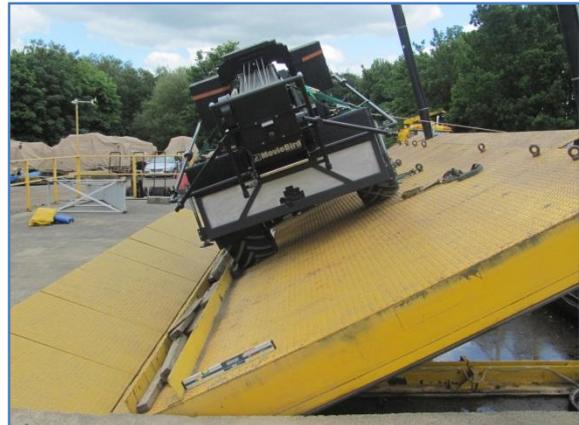
Figure 10 - Config. 4, Rear View, 26.7° Platform
